## MECHANICS FACE WAS STRUCK WITH CABLE SLING

Fuel type: Mining  
Plant/Location: SunHills  
Classification: Medical Aid  
Incident # SHM-1508-8

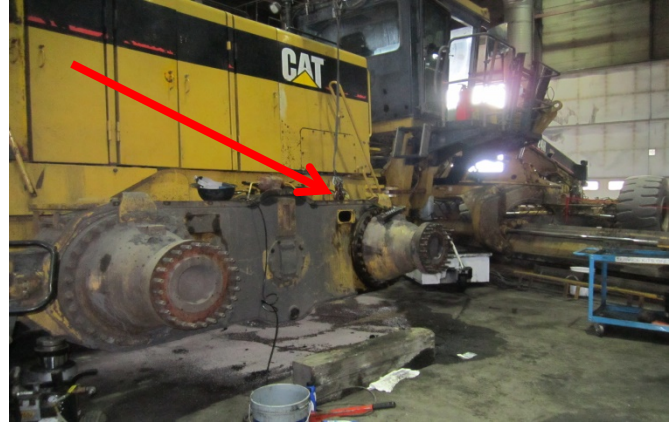
**WHAT HAPPENED?** On 31 Aug 2015, a contract mechanic was using the shop bay crane to position a drive chain in the drive case. When he used the crane control to move the chain the free end of the cable sling hooked the edge of the drive case. The cable end shot out and contacted his helmet, his forehead and eye brow causing a laceration.

*Location where mechanic was struck in the face*

**CIRCUMSTANCES** A Contract Mechanic was using the shop 20 Tonne crane to position a drive chain in the grader housing. One end of the double cable bridle was attached to a 1 inch nylon sling, which was attached to the drive chain. Once the crane control activated the second leg of the two leg bridal (Hook) caught the edge of the drive casing and shot out contacting the mechanics helmet. The edge of the helmet was broken off from the contact. It is undetermined if the broken edge of the helmet or the hook made contact with his left forehead and eyebrow casing an approx... 1 inch laceration to the worker.

**BE AWARE OF LINE OF FIRE AND ENSURE YOU ARE USING THE CORRECT TOOL FOR THE JOB.**

- Emergency response plan was activated and first aid administered by mine rescue team/site paramedic
- Contractor was transported to hospital for medical treatment.
- Joint Investigation started with Contract Company.
