# Fire Extinguisher Explosion on DZ 28

Friday Nightshift 7<sup>th</sup> May 2010

D Crew

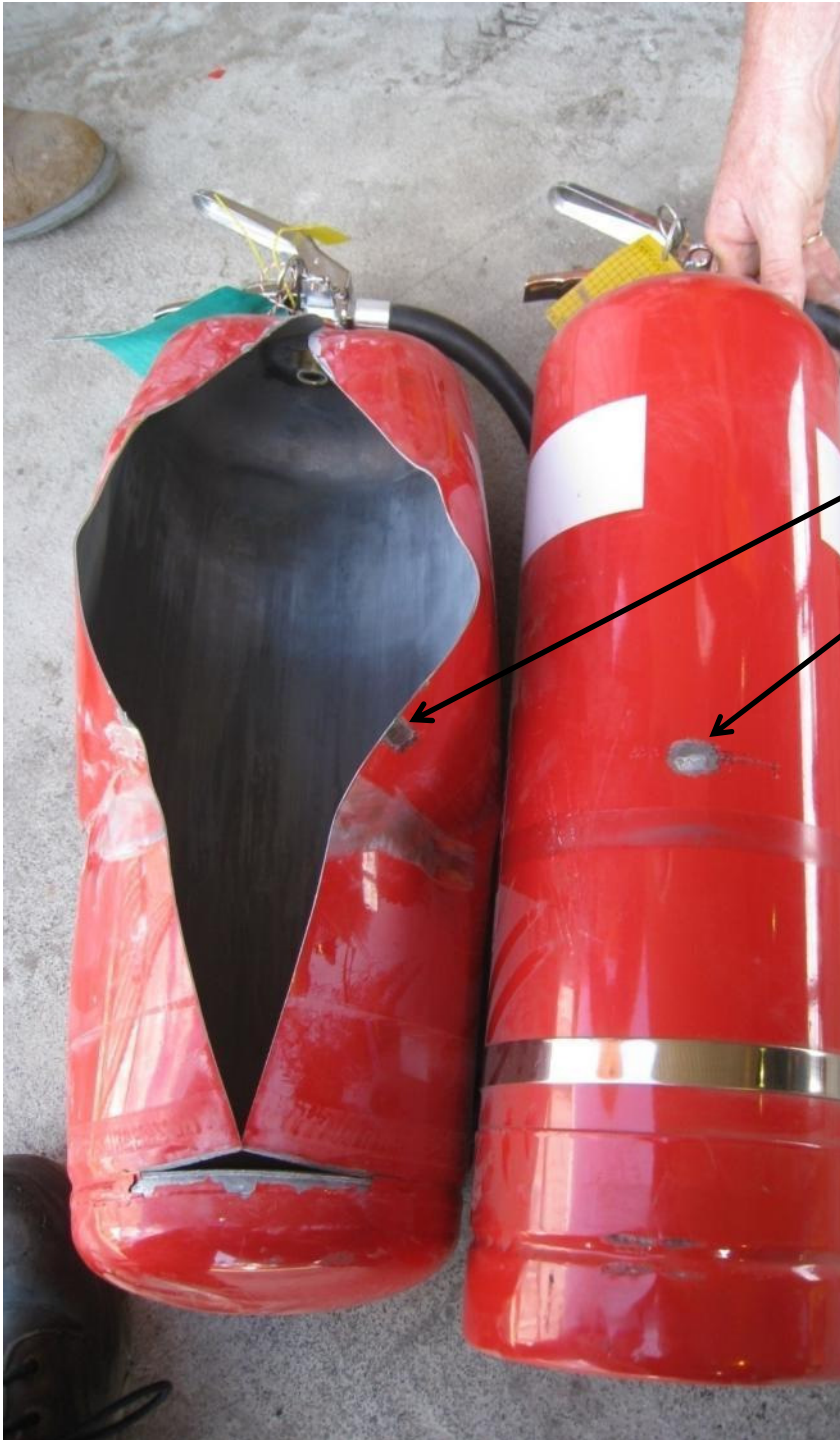
**Bracket bolt head appears to have created wear area resulting in fatigue cracking**

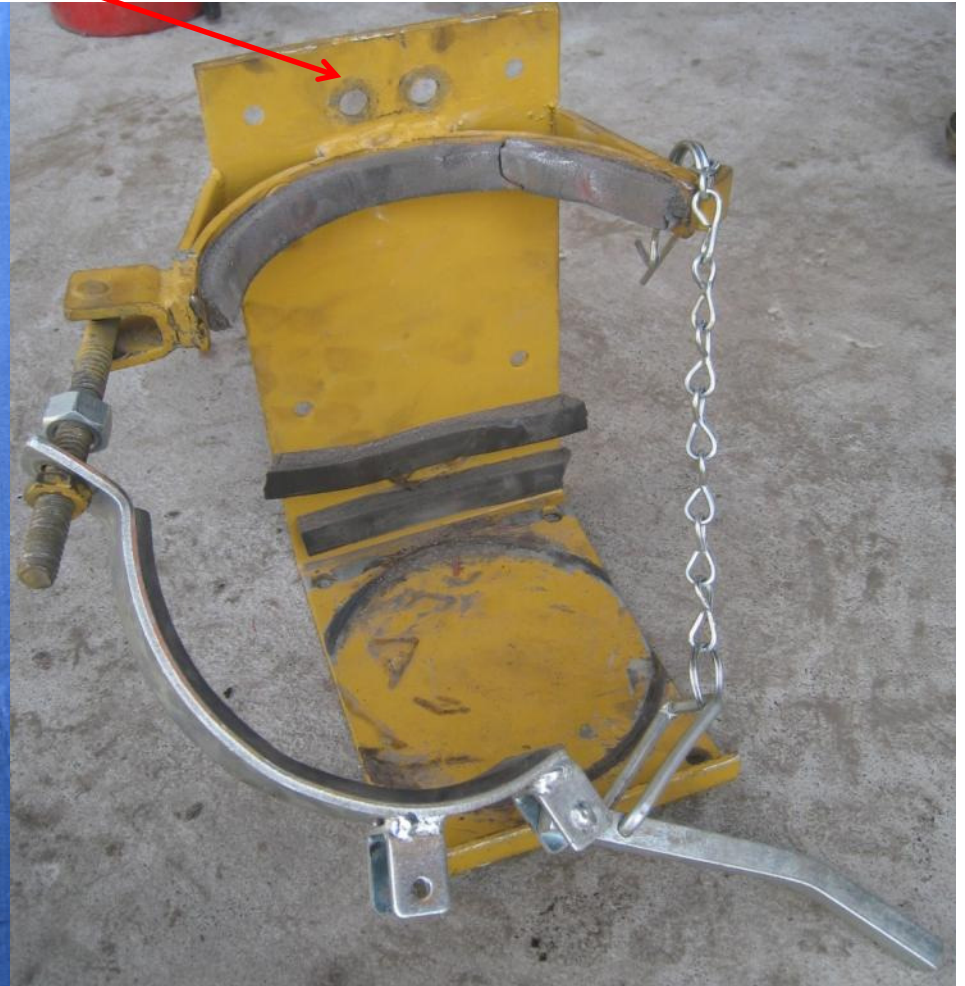
# Actual Bracket Involved

## Arrows point to bolt location

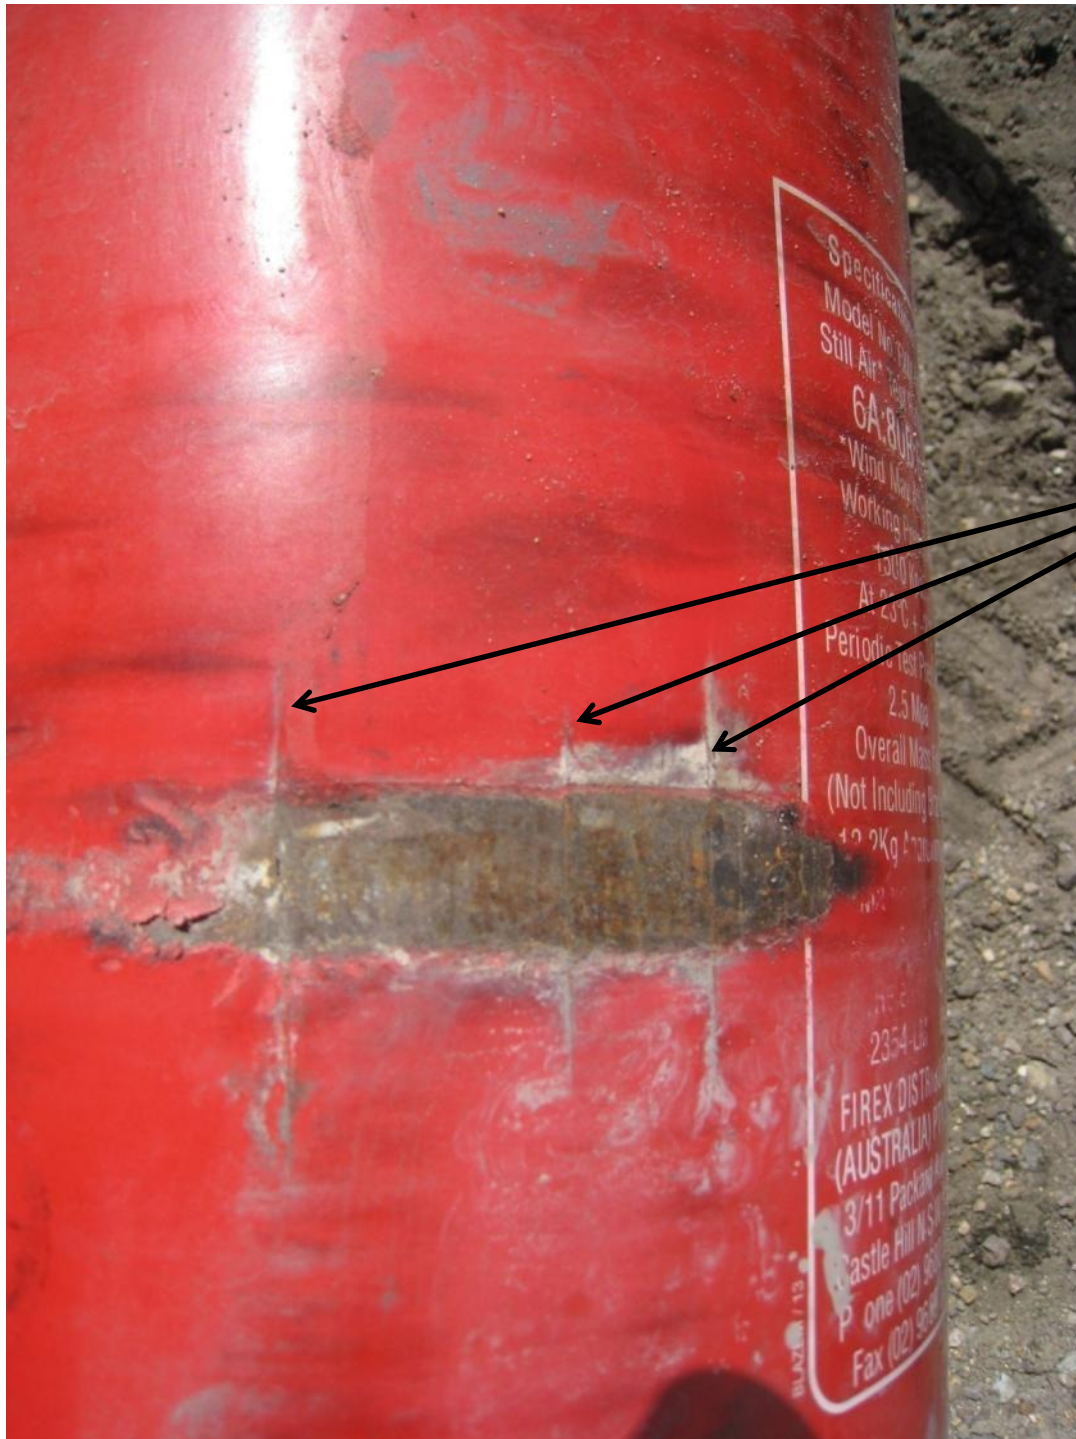
**Fatigue cracking**

**Third extinguisher showing wear from  
bracket strap rubbing**

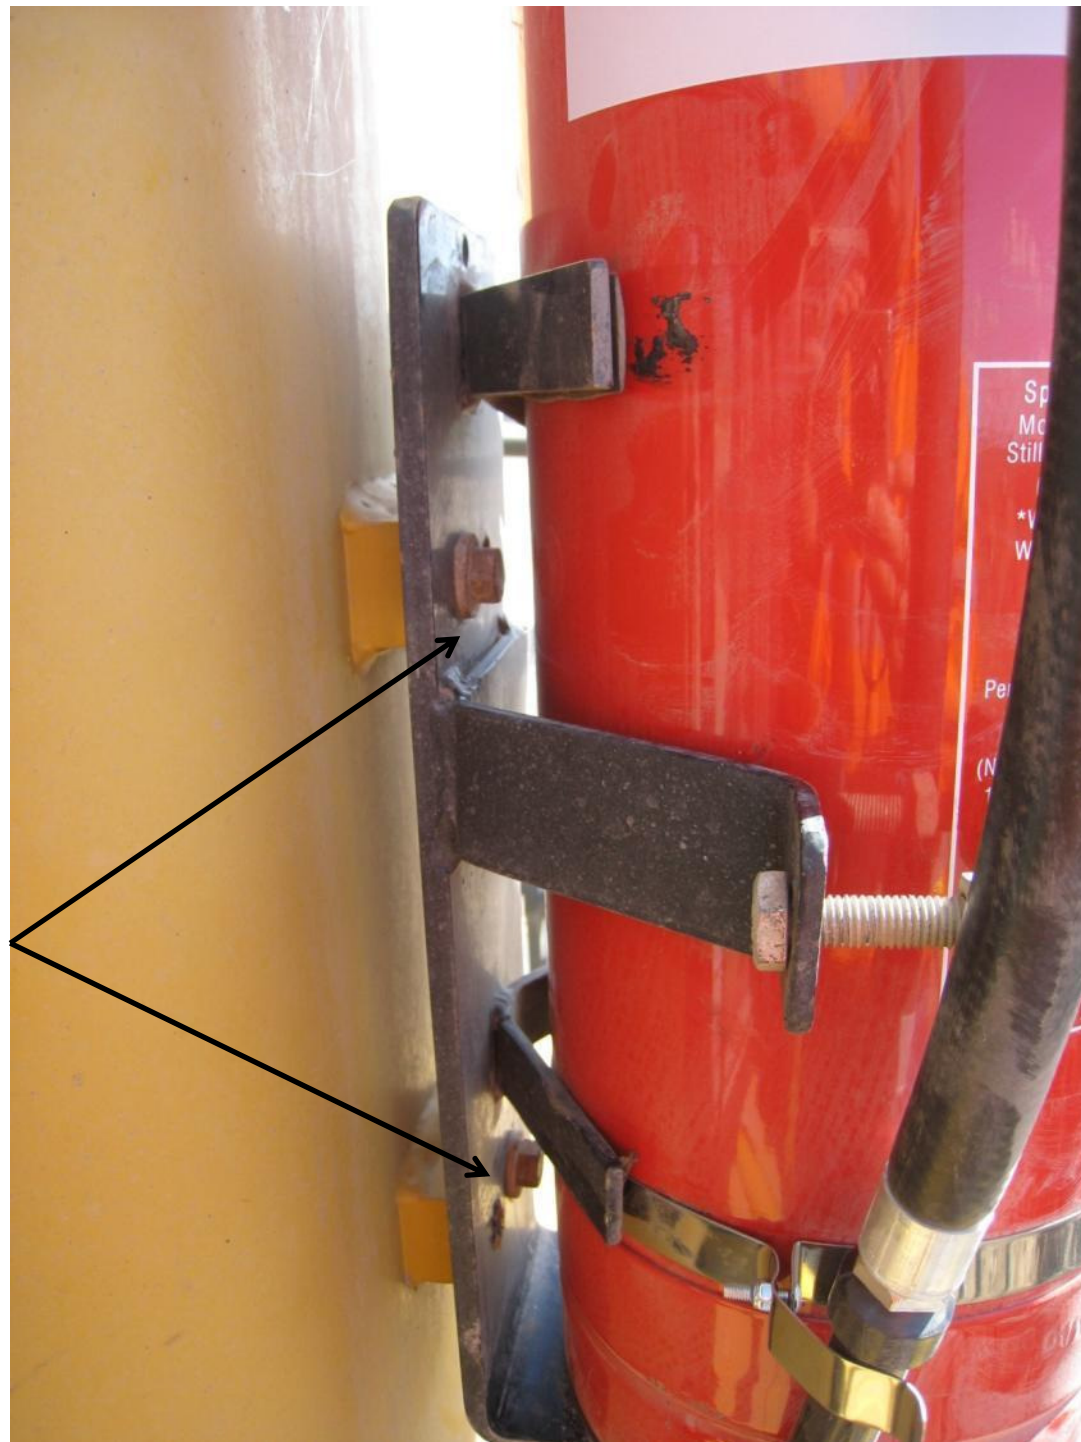
Alternate bracket design showing  
adequate gap between bolt heads and  
extinguisher
